**Flood Control Project Maintenance  
Levee Inspections**  
**LMA District Cover Sheet**  
**Spring 2019 Levee Inspection Results**

**Sacramento River West Side Levee District**

**Spring 2019 Levee Inspection Results**

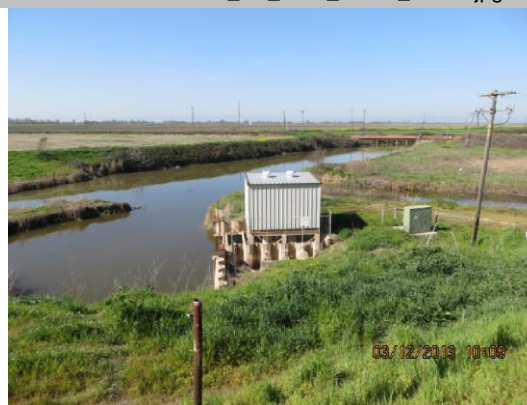
Photo 1 of 3 : UCIP\_SP\_2019\_10087\_17235.jpg

LM Start	0.14	Rating **	M	Issue No.	1551
LM End	0.14	Issue Type +	Ma	Location *	
Category	Supplemental			GPS Latitude/Longitude	
				Start	End
Item	DWR UCIP LMA Responsibility			38.801471 °	38.801471 °
				-121.725171 °	-121.725171 °
DWR ID	20224				
Comment Code					
Inspector Comment					
FS_ID:10087 DS_ID:20224 EP_NO: N/A Repair Type: Non-Urgent Crossing Status: Found UCIP Comments: Headwall on WS undermined about 3-4-feet. FIELD_STRUCT_DESC: 1 of 3: 36-inch steel drainage pipe through the levee, 30.0 feet below the crown. Flap gate on the waterside (WS) end. 24-inch pipe sleeved through the 36-inch pipe. Annular space between pipes grouted. Pumps in pump house with walkway on landside (LS) toe. [Additional Reference(s): DWR Levee Log, 2006. USACE Sacramento O&M Manual 130, May 1960 (HLM 0.15)]. FS Date: 3/12/2013

Pumphouse at LS toe.

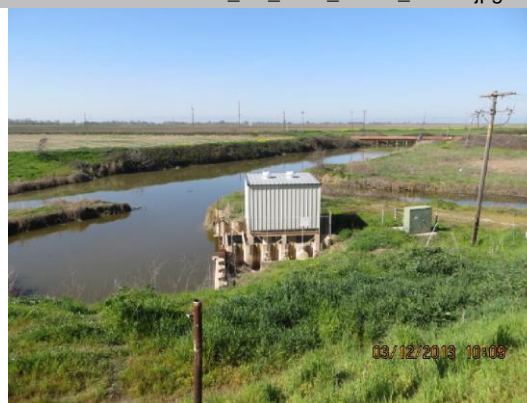
Photo 1 of 3 : UCIP\_SP\_2019\_10085\_17227.jpg

Comment Code						
Inspector Comment						
FS_ID:10085						
DS_ID:20356						
EP_NO: N/A						
Repair Type: Non-Urgent						
Crossing Status: Found						
UCIP Comments: Headwall undermined 3-4-feet on WS toe.						
FIELD_STRUCT_DESC: 2 of 3: 36-inch steel drainage pipe through the						
levee, 30 feet below the crown. Flap gate on the waterside (WS) end.						
24-inch pipe sleeved through the 36-inch pipe. Annular space between						
pipes grouted. Pumps inside pump house with a walkway on the						
landside (LS) toe. [Additional Reference(s): DWR Levee Log, 2006.						
USACE Sacramento O&M Manual 130, May 1960 (HLM 0.15)].						
FS Date: 3/12/2013

Pump house on LS toe.

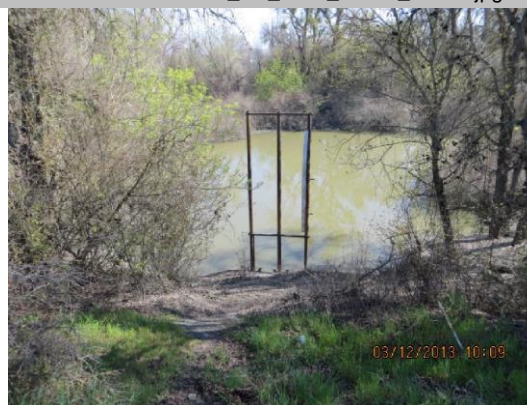
Photo 2 of 3 : UCIP\_SP\_2019\_10085\_17226.jpg

Air vents on pipes at WS toe.

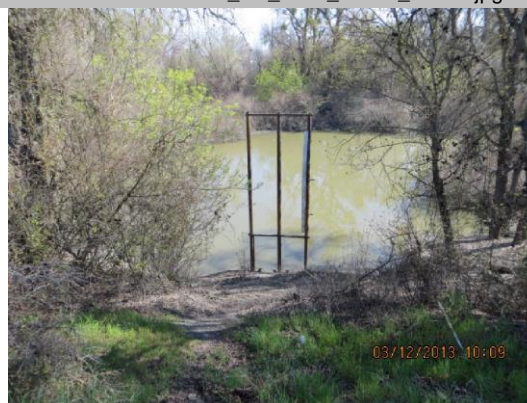
Photo 2 of 3 : UCIP\_SP\_2019\_10910\_18184.jpg

Air vents on pipes at WS toe.

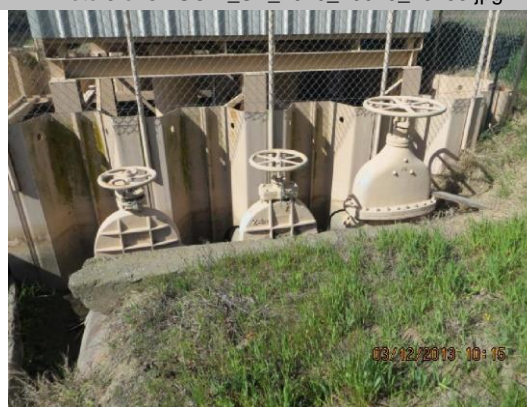
Photo 3 of 3 : UCIP\_SP\_2019\_10910\_18183.jpg

Slide gates at pumphouse on LS toe.

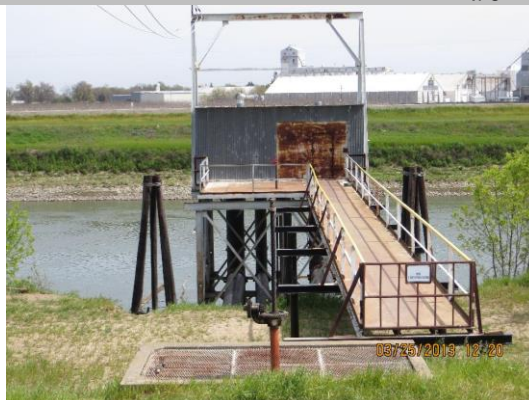
Photo 2 of 3 : UCIP\_SP\_2019\_10103\_17261.jpg

Comment Code						
Inspector Comment						
FS_ID:10103 DS_ID:20226 EP_NO: 1331 Repair Type: Non-Urgent Crossing Status: Found UCIP Comments: There is no gate in the slide gate at the concrete distribution box off the landside toe. This may not be an issue as there is a slide gate at the WS toe. FIELD_STRUCT_DESC: 54-inch corrugated metal irrigation pipe through the levee, 28 feet below the crown. Vertical pumps on a pile structure in the stream. Walkway to pumps. Flap gates from pumps and slide gate inside a 7-foot by 10-foot concrete surge box on the waterside (WS), 1948 installation. 15-foot by 18-foot concrete distribution box 150 feet off landside (LS) toe with slide gate. (Permit No. 1331, 1948 - River Farms Company of California). [Additional Reference(s): DWR Levee Log, 2006. USACE Sacramento O&M Manual 130, May 1960 (HLM 0.47)]. FS Date: 3/25/2013 7:36:51 AM

Pumping plant with concrete surge box and slide gate in foreground-off WS toe.

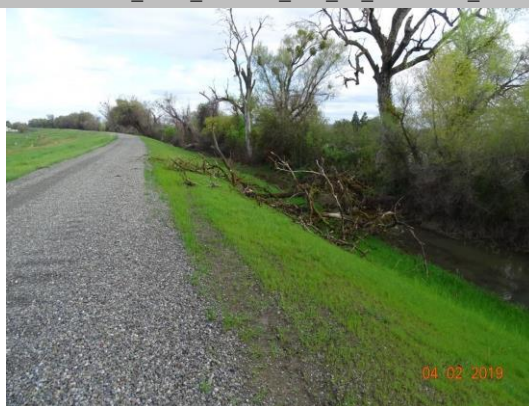
Photo 1 of 1 : SP\_2019\_NA0016\_435\_76\_20190404\_00210.jpg

LM Start	2.09	Rating **	M	Issue No.	76
LM End	2.09	Issue Type +	Ma	Location *	WS
Category	Earthen Levee			GPS Latitude/Longitude	
				Start	End
Item	Encroachments			38.828597 °	38.828597 °
				-121.726049 °	-121.726049 °
DWR ID	DWR_NA0016_01_s_2019_76				
Comment Code					
TR : Tree or limb					
Inspector Comment					
A fallen tree is located on the waterside slope.

View of fallen tree on the waterside slope. Spring 2019.

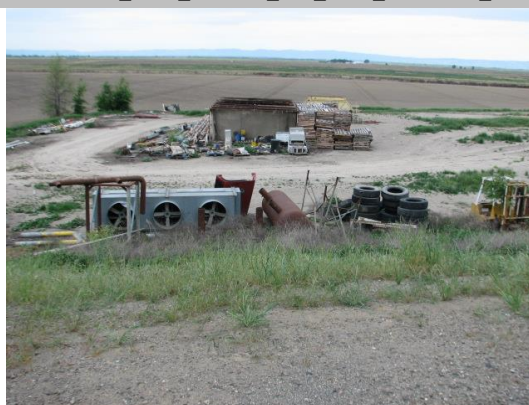
Photo 1 of 2 : SP\_2019\_NA0016\_435\_1550\_20190304\_00063.jpg

LM Start	2.40	Rating **	M	Issue No.	1550
LM End	2.40	Issue Type +	En	Location *	LS
Category	Earthen Levee			GPS Latitude/Longitude	
				Start	End
Item	Encroachments			38.832295 °	38.832295 °
				-121.729408 °	-121.729408 °
DWR ID	DWR_NA0016_01_f_2013_1550				
Comment Code					
EQ : Equipment					
Inspector Comment					
Equipment is located at the levee toe.

Pieces of machinery and debris at the levee toe. Spring 2014

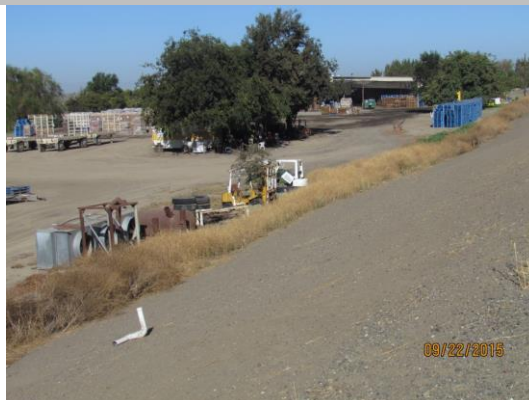
Photo 2 of 2 : SP\_2019\_NA0016\_435\_1550\_20190304\_00064.jpg

View of the machinery along the landward levee toe looking upstream. Fall 2015.

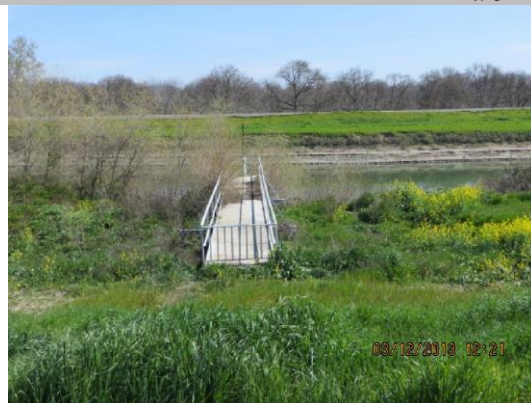
Photo 1 of 3 : UCIP\_SP\_2019\_10125\_17283.jpg

LM Start	3.54	Rating **	A/W	Issue No.	1556
LM End	3.54	Issue Type +	Ma	Location *	
Category	Supplemental			GPS Latitude/Longitude	
				Start	End
Item	DWR UCIP LMA Responsibility			38.846492 °	38.846492 °
				-121.730066 °	-121.730066 °
DWR ID	20331				
Comment Code					
Inspector Comment					
FS_ID:10125 DS_ID:20331 EP_NO: N/A Repair Type: No Action Needed Crossing Status: Found UCIP Comments: FIELD_STRUCT_DESC: 5-foot by 5-foot reinforced concrete box drainage tunnel through the levee, 33 feet below the crown. Slide gate at outlet on the waterside (WS) toe. Tunnel runs from concrete U-shaped riser unit on the landside (LS) shoulder to the WS toe. Steel walkway to slide gate actuator on the WS berm. [Additional Reference(s): USACE Sacramento O&M Manual 130, May 1960 (HLM 3.59)]. FS Date: 3/12/2013

Steel walkway on WS berm with Slide gate actuator.

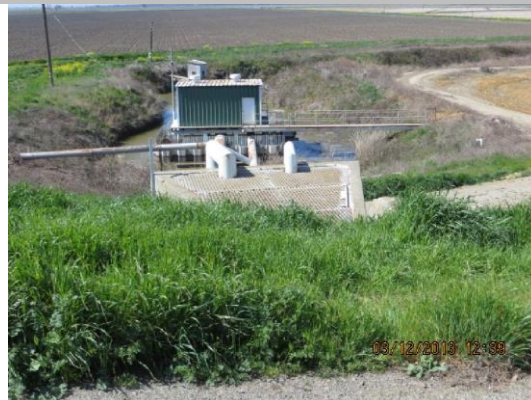
Photo 2 of 3 : UCIP\_SP\_2019\_10125\_17282.jpg

Pumphouse at LS toe and concrete riser on LS shoulder.

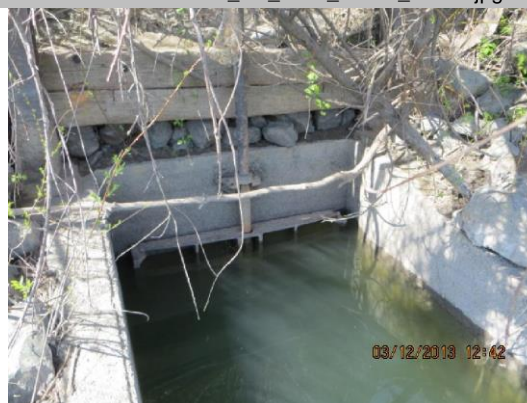
Photo 3 of 3 : UCIP\_SP\_2019\_10125\_17281.jpg

Slide gate at outlet at river side.

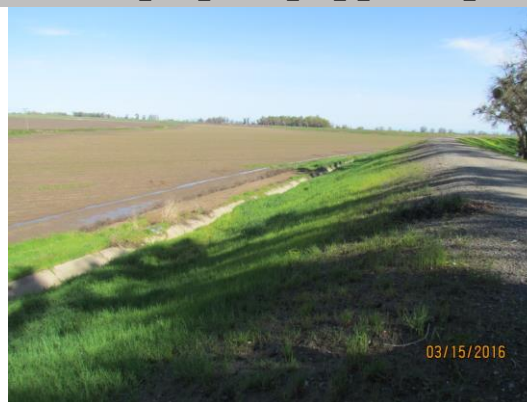
Photo 1 of 1 : SP\_2019\_NA0016\_435\_8\_20190304\_00001.jpg

LM Start	3.56	Rating **	M	Issue No.	8
LM End	3.94	Issue Type +	En	Location *	LS
Category	Earthen Levee			GPS Latitude/Longitude	
				Start	End
Item	Encroachments			38.846785 °	38.850758 °
				-121.729995 °	-121.725263 °
DWR ID	DWR_NA0016_01_s_2012_8				
Comment Code					
DT : Ditch					
Inspector Comment					
Concrete lined ditch runs along the levee toe.

View of the ditch on the landward side of the levee looking upstream.  
Spring 2016.

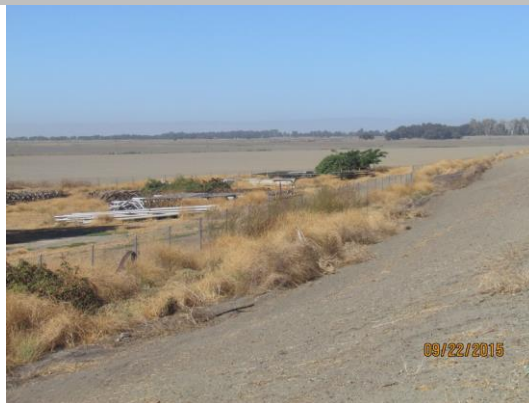
Photo 1 of 1 : SP\_2019\_NA0016\_435\_9\_20190304\_00002.jpg

LM Start	4.80	Rating **	M	Issue No.	9
LM End	4.80	Issue Type +	En	Location *	LS
Category	Earthen Levee			GPS Latitude/Longitude	
				Start	End
Item	Encroachments			38.859446 °	38.859446 °
				-121.732774 °	-121.732774 °
DWR ID	DWR_NA0016_01_s_2012_9				
Comment Code					
FE : Fence					
Inspector Comment					
A chain link fence runs along levee toe.

View of the chain link fence along the landward levee toe looking upstream. The fence does not obstruct the view. Fall 2015.

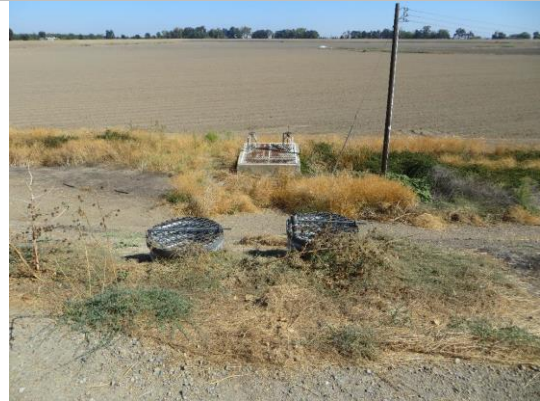
Photo 2 of 3 : UCIP\_SP\_2019\_46766\_74706.jpg

Comment Code						
Inspector Comment						
FS_ID:46766 DS_ID:25126 EP_NO: 8501 Repair Type: Non-Urgent Crossing Status: Found UCIP Comments: a few actions are recommended based on field inspection: 1. clear out metal fence posts near daylight of pipe on water side levee. 2. clear vegetation around pipes on water side of levee to aid in inspection. 3. monitor burrowing activities on water side of levee. FIELD_STRUCT_DESC: 2 of 2: 20-inch steel irrigation pipe, at an unknown depth, and 16-inch steel irrigation pipe, at an unknown depth, are located at levee mile 6.889 and 6.89, respectively. Both pipes have a protective paint coating. The pipes are used to supply irrigation water to the adjacent fields. On the waterside (WS) of the levee, the pipes are above ground and follow the slope of the bank into the river. A metal pump house, supported on a steel frame, is located on a bench on the WS of the levee. When the pumps are operational, a drum fish screen is lowered over the pipe intakes on a track. Both irrigation pipes travel through the levee and have siphon breakers inside corrugated metal riser units on the landside (LS) crest of the levee. The pipes discharge under submerged conditions to a 9.5-foot by 12-foot concrete distribution box. There are two gated outlets on the distribution box that lead to distribution canals. FS Date: 10/9/2015

view from levee crest along pipe looking towards land side. shows siphon breaker standpipes and distribution box.

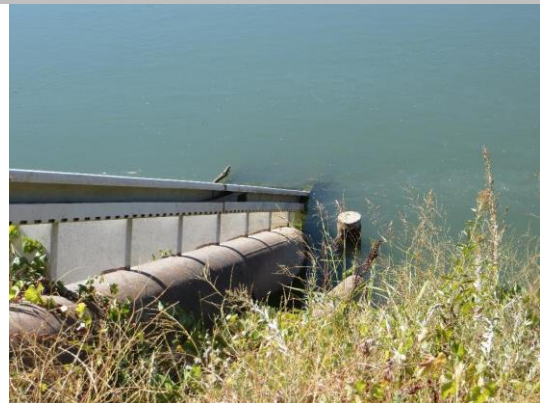
Photo 3 of 3 : UCIP\_SP\_2019\_46766\_74707.jpg

pipe intake in river. shows pipes entering water and track for drum fish screen.

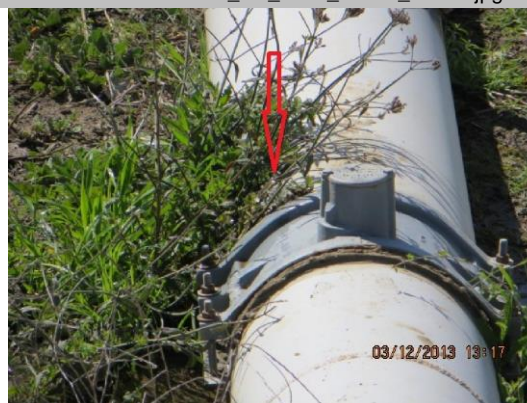
Photo 1 of 3 : UCIP\_SP\_2019\_10129\_17291.jpg

Comment Code					
Inspector Comment					
FS_ID:10129 DS_ID:20228 EP_NO: 1297 Repair Type: Non-Urgent Crossing Status: Found UCIP Comments: Leak at flowmeter on WS berm may become problem in near future. FIELD_STRUCT_DESC: *REMOVED* 2 of 2: 16-inch steel irrigation pipe through the levee, 5.2 feet below the crown. Slant pumps in a metal pump house on the waterside (WS) bank, supported on a steel structure. Pipes discharge into a 9.5-foot by 12-foot concrete distribution box on the landside (LS). Sparline flow meter on pipes near the WS toe. (Permit No. 1297, 1948 - River Farms Company of California; removed under Permit No. 8501, 2012 - River Garden Farms, Inc.). [Additional Reference(s): DWR Levee Log, 2006. USACE Sacramento O&M Manual 130, May 1960 (HLM 6.89) listed as a 14-inch pipe]. FS Date: 3/12/2013

Minor leak at flowmeter on WS berm.

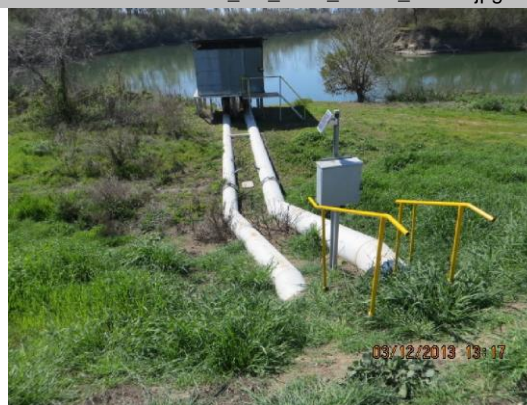
Photo 2 of 3 : UCIP\_SP\_2019\_10129\_17290.jpg

Pumphouse and steps on WS.

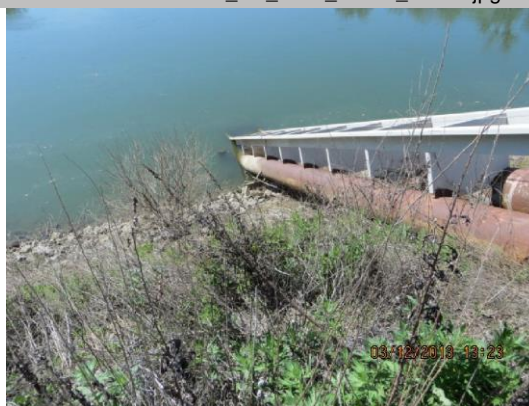
Photo 3 of 3 : UCIP\_SP\_2019\_10129\_17289.jpg

Pipe and fish screen ramp on WS.

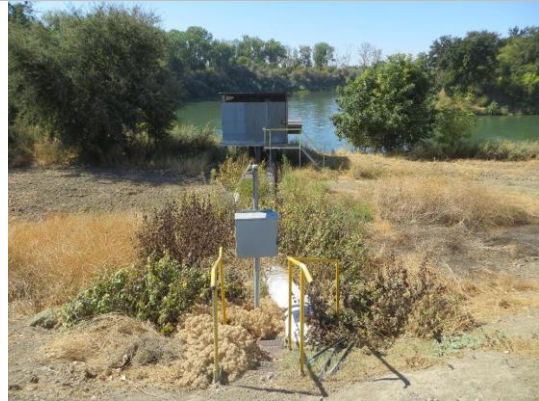
Photo 1 of 3 : UCIP\_SP\_2019\_46765\_74700.jpg

Comment Code						
Inspector Comment						
FS_ID:46765 DS_ID:25125 EP_NO: 8501 Repair Type: Non-Urgent Crossing Status: Found UCIP Comments: field inspection of the site revealed a few minor actions: 1. there are metal fence posts located near the pipe that should be cleared out for safety, 2. vegetation around the pipes should be cleared as it limits inspection, 3. some burrowing activity was noticed nearby the pipes. FIELD_STRUCT_DESC: 1 of 2: 20-inch steel irrigation pipe, at an unknown depth, and 16-inch steel irrigation pipe, at an unknown depth, are located at levee mile 6.889 and 6.89, respectively. Both pipes have a protective paint coating. The pipes are used to supply irrigation water to the adjacent fields. On the waterside (WS) of the levee, the pipes are above ground and follow the slope of the bank into the river. A metal pump house, supported on a steel frame, is located on a bench on the WS of the levee. When the pumps are operational, a drum fish screen is lowered over the pipe intakes on a track. Both irrigation pipes travel through the levee and have siphon breakers inside corrugated metal riser units on the landside (LS) crest of the levee. The pipes discharge under submerged conditions to a 9.5-foot by 12-foot concrete distribution box. There are two gated outlets on the distribution box that lead to distribution canals. FS Date: 10/9/2015 9:00:32 AM

view from levee crest along pipe profile on water side of levee. pipe daylight from levee and pumphouse.

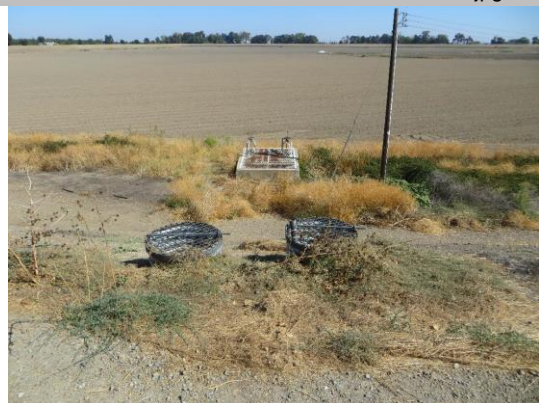
Photo 2 of 3 : UCIP\_SP\_2019\_46765\_74701.jpg

view from levee crest along pipe profile toward land side of levee. CMP risers with siphon breakers and distribution box near land side levee toe.

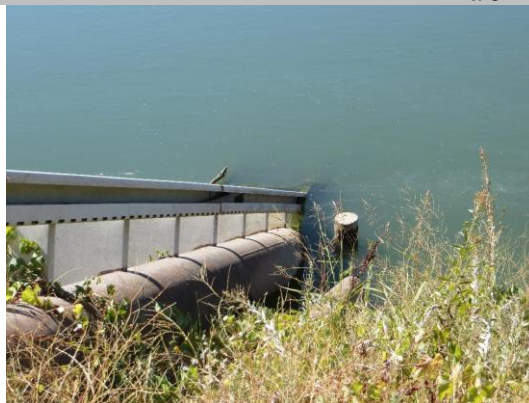
Photo 3 of 3 : UCIP\_SP\_2019\_46765\_74702.jpg

pipe intake in river. track above pipe is for drum fish screen.

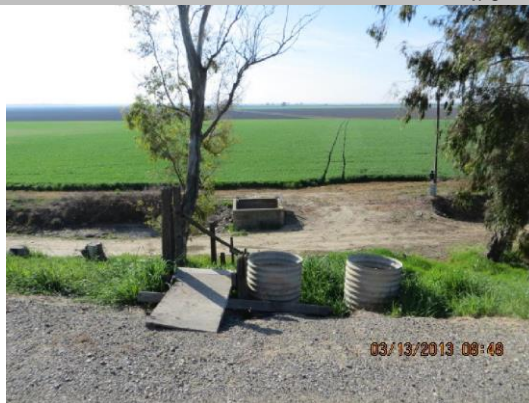
Photo 1 of 3 : UCIP\_SP\_2019\_10144\_17307.jpg

Comment Code					
Inspector Comment					
FS_ID:10144 DS_ID:20428 EP_NO: 18206 Repair Type: Non-Urgent Crossing Status: Found UCIP Comments: Flap gates rusted through at concrete distribution box on LS toe. FIELD_STRUCT_DESC: 1 of 2: 20-inch steel irrigation pipe through the levee, 4.7 feet below the crown. Slant pump inside pump house on the waterside (WS) berm. Siphon breaker inside corrugated metal riser unit on the shoulder. Flap gate on pipe inside concrete distribution box on the landside (LS). Wooden steps on both slopes. (Permit No. 18206, 2007 - River Garden Farms). (Replaced 20-inch pipe installed under Permit No. 9377, 1974 - Faye Properties, Inc.). [Additional Reference(s): DWR Levee Log, 2006]. FS Date: 3/13/2013

Stairs, distribution box, and air vent in CMP riser on LS.

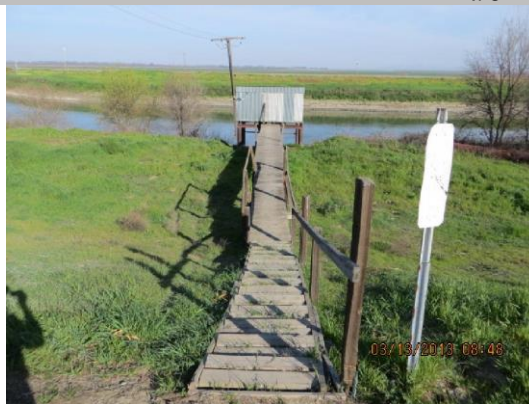
Photo 2 of 3 : UCIP\_SP\_2019\_10144\_17306.jpg

Stairs and pump on WS.

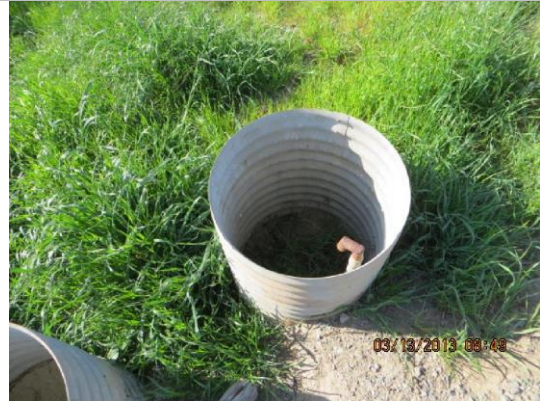
Photo 3 of 3 : UCIP\_SP\_2019\_10144\_17305.jpg

Air vent in CMP riser on LS shoulder.

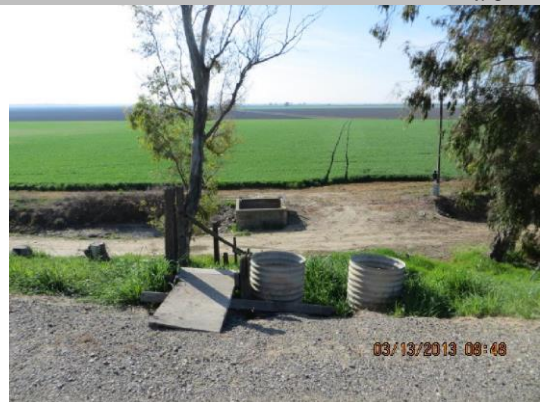
Photo 1 of 3 : UCIP\_SP\_2019\_10143\_17302.jpg

Comment Code						
Inspector Comment						
FS_ID:10143 DS_ID:20427 EP_NO: 18206 Repair Type: Non-Urgent Crossing Status: Found UCIP Comments: Flap gates rusted through at LS distribution box. FIELD_STRUCT_DESC: 2 of 2: 16-inch steel irrigation pipe through the levee, 4.7 feet below the crown. Slant pump inside pump house on the waterside (WS) berm. Siphon breaker inside corrugated metal riser unit on the shoulder. Flap gate on pipe inside concrete distribution box on the landside (LS). Wooden steps on both slopes. (Permit No. 18206, 2007 - River Garden Farms). (Replaced 16-inch pipe installed under Permit No. 9377, 1974 - Faye Properties, Inc.). [Additional Reference(s): DWR Levee Log, 2006]. FS Date: 3/13/2013

Steps, air vent in riser, and distribution box on LS.

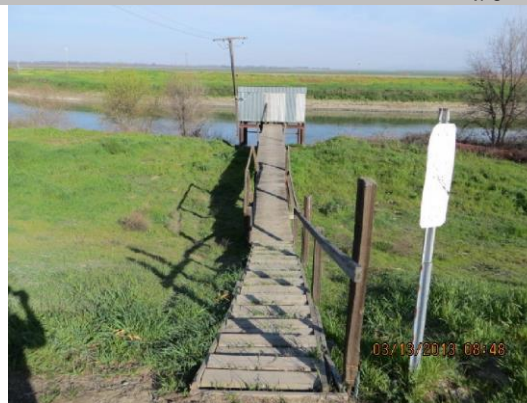
Photo 2 of 3 : UCIP\_SP\_2019\_10143\_17301.jpg

Comment Code						
Inspector Comment						
FS_ID:10143 DS_ID:20427 EP_NO: 18206 Repair Type: Non-Urgent Crossing Status: Found UCIP Comments: Flap gates rusted through at LS distribution box. FIELD_STRUCT_DESC: 2 of 2: 16-inch steel irrigation pipe through the levee, 4.7 feet below the crown. Slant pump inside pump house on the waterside (WS) berm. Siphon breaker inside corrugated metal riser unit on the shoulder. Flap gate on pipe inside concrete distribution box on the landside (LS). Wooden steps on both slopes. (Permit No. 18206, 2007 - River Garden Farms). (Replaced 16-inch pipe installed under Permit No. 9377, 1974 - Faye Properties, Inc.). [Additional Reference(s): DWR Levee Log, 2006]. FS Date: 3/13/2013

Stairs, pump platform on WS.

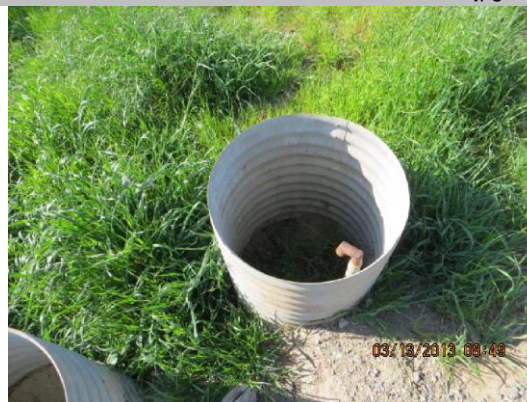
Photo 3 of 3 : UCIP\_SP\_2019\_10143\_17300.jpg

Vent in riser on LS shoulder.

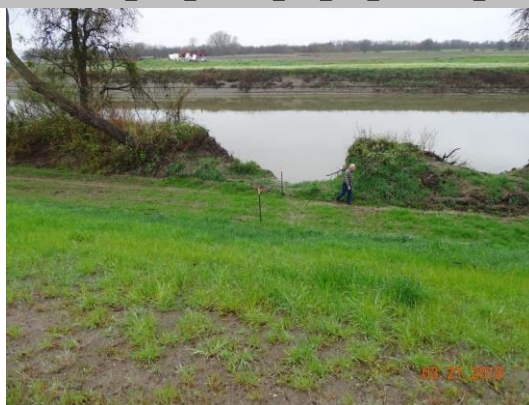
Photo 2 of 4 : SP\_2019\_NA0016\_435\_112\_20190304\_00040.jpg

LM Start	8.55	Rating **	A/W	Issue No.	112
LM End	8.55	Issue Type +	Ma	Location *	WS
Category	Earthen Levee			GPS Latitude/Longitude	
				Start	End
Item	Erosion / Bank Caving			38.857422 °	38.857422 °
				-121.780870 °	-121.780870 °
DWR ID	DWR_NA0016_01_s_2018_112				
Comment Code					
E1 : Note and monitor erosion site.					
Inspector Comment					
Location on waterside berm where oak tree fell and removed soil around the roots. New erosion as of the Spring 2019 inspection date. Recommend monitoring.

View of the berm where the oak tree used to stand, facing the Sacramento River. Spring 2018.

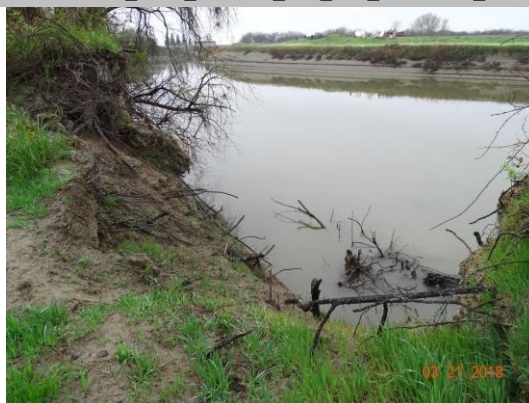
Photo 3 of 4 : SP\_2019\_NA0016\_435\_112\_20190304\_00041.jpg

View of the remaining roots, facing upstream. Spring 2018.

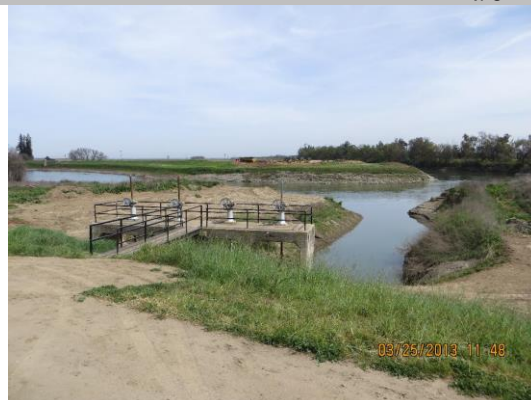
Photo 2 of 3 : UCIP\_SP\_2019\_10146\_17311.jpg

Walkway to slide gate actuators on WS shoulder.

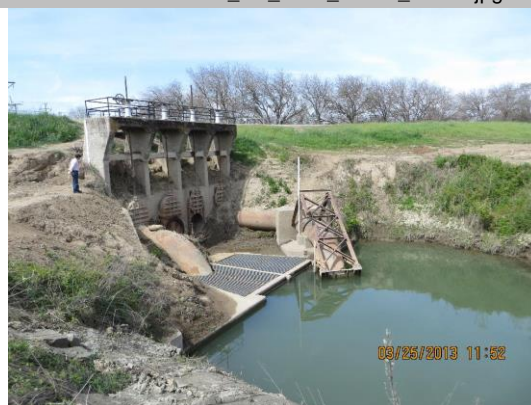
Photo 3 of 3 : UCIP\_SP\_2019\_10146\_17310.jpg

Pipes at outlet on WS toe.

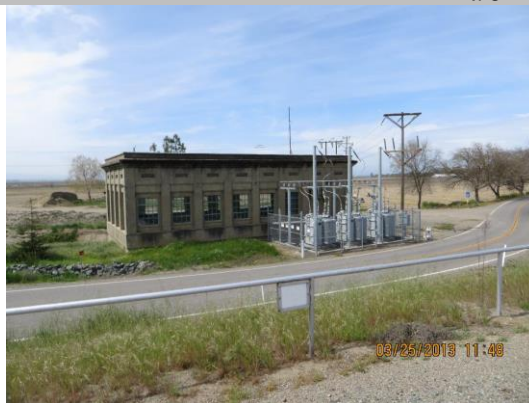
Photo 1 of 3 : UCIP\_SP\_2019\_10147\_17316.jpg

Pumphouse on LS toe.

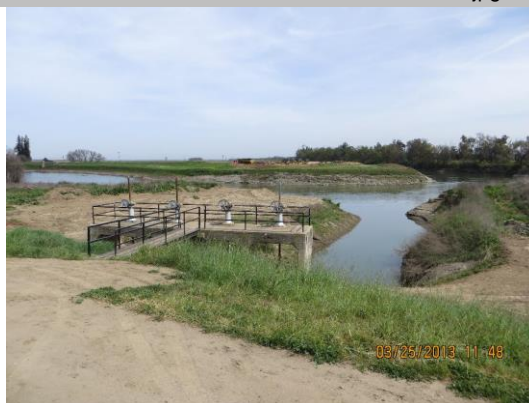
Photo 2 of 3 : UCIP\_SP\_2019\_10147\_17315.jpg

Walkway to slide gate actuators on WS shoulder.

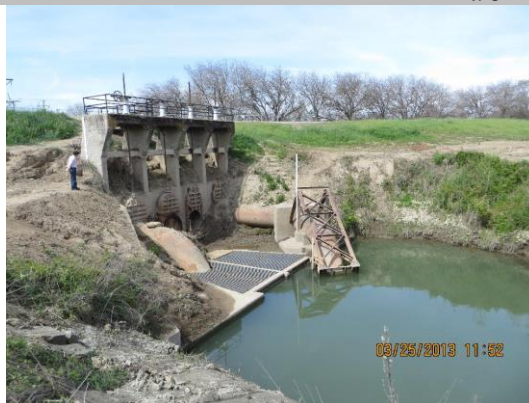
Photo 3 of 3 : UCIP\_SP\_2019\_10147\_17314.jpg

Slide gates and pipes at outlet structure on WS toe.

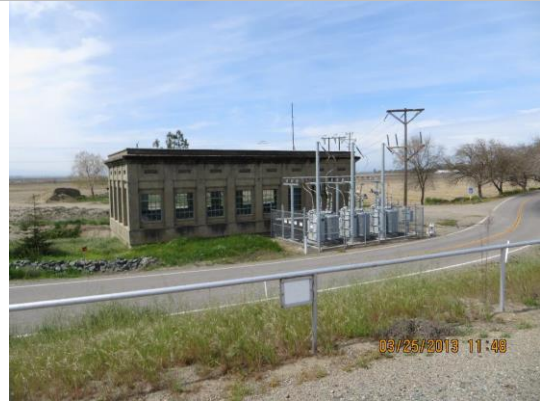
Pumphouse on LS.

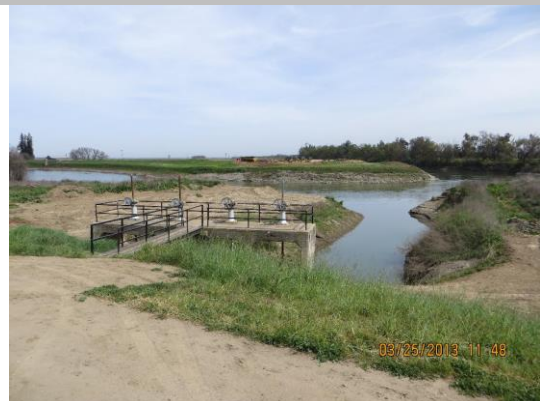
Slide gate actuators on platform at WS shoulder.

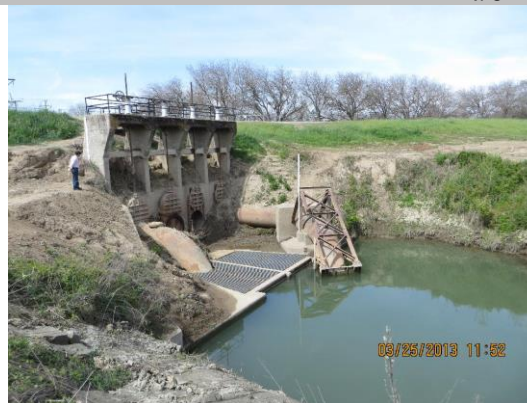
Photo 3 of 3 : UCIP\_SP\_2019\_10148\_17318.jpg

Pipes at outlet on WS.

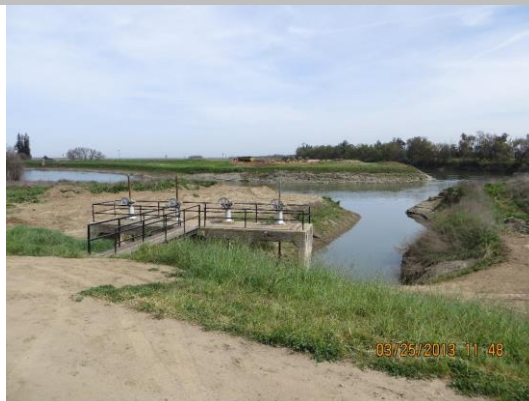
Photo 2 of 3 : UCIP\_SP\_2019\_10149\_17323.jpg

Slide gate actuators on platform at WS shoulder.

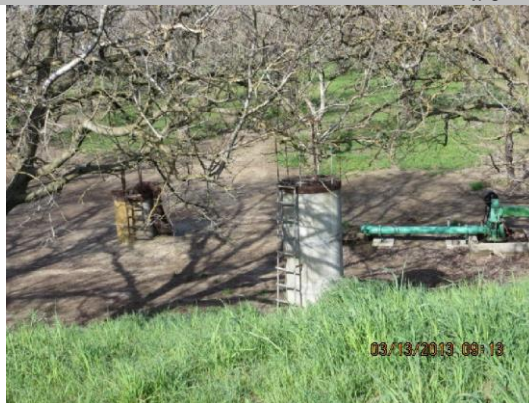
Photo 1 of 3 : UCIP\_SP\_2019\_50039\_17328.jpg

Comment Code						
Inspector Comment						
FS_ID:50039 DS_ID:20231 EP_NO: 1641 Repair Type: Non-Urgent Crossing Status: Found UCIP Comments: 09/23/2016 - pipe is not actively used. No power to pump platform. vegetation growth obscuring view along pipe alignment on the WS toe (T.Hatch/UCIP) 09/01/2016 pipe is visible on the WS slope of the levee. The pipe appears intact on the WS and does not appear to have a meter. The siphon breaker on the LS slope appears to have been removed and replaced by a cap. No holes or missing connections were visible. WS levee slope appears to have a slight depression in the vicinity of the exposed pipe. (T. Hatch/UCIP)  03/13/2013 - Meter removed from the pipe on the WS and pipe is open. Pipe appears abandoned, and, if so, should be abandoned properly. (W. Wylie/UCIP) FIELD_STRUCT_DESC: *ABANDONED* 14-inch steel irrigation pipe through the levee, 5.2 feet below the crown. Slant pump on a concrete pump platform on the waterside (WS). Siphon breaker on the landside (LS) slope. Sparling flow meter on the pipe on the WS slope. 42-inch concrete standpipe in a concrete distribution box at the landside (LS) toe. (Permit No. 1641, 1952 - William Erdman Jr.). [Additional Reference(s): DWR Levee Log, 2006. USACE Sacramento O&M Manual 130, May 1960 (HLM 9.31)]. FS Date: 9/23/2016

Concrete riser on LS toe.

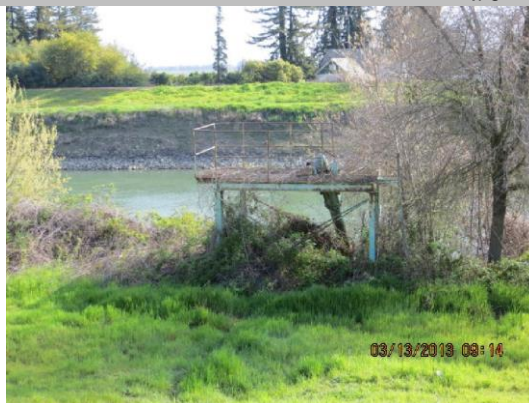
Photo 2 of 3 : UCIP\_SP\_2019\_50039\_17327.jpg

Pump platform on WS.

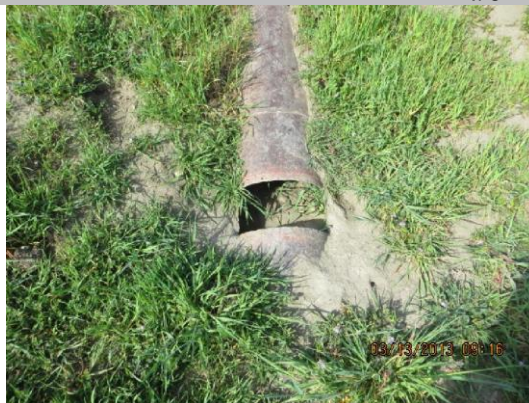
Photo 3 of 3 : UCIP\_SP\_2019\_50039\_17326.jpg

Comment Code						
Inspector Comment						
FS_ID:50039 DS_ID:20231 EP_NO: 1641 Repair Type: Non-Urgent Crossing Status: Found UCIP Comments: 09/23/2016 - pipe is not actively used. No power to pump platform. vegetation growth obscuring view along pipe alignment on the WS toe (T.Hatch/UCIP) 09/01/2016 pipe is visible on the WS slope of the levee. The pipe appears intact on the WS and does not appear to have a meter. The siphon breaker on the LS slope appears to have been removed and replaced by a cap. No holes or missing connections were visible. WS levee slope appears to have a slight depression in the vicinity of the exposed pipe. (T. Hatch/UCIP)  03/13/2013 - Meter removed from the pipe on the WS and pipe is open. Pipe appears abandoned, and, if so, should be abandoned properly. (W. Wylie/UCIP) FIELD_STRUCT_DESC: *ABANDONED* 14-inch steel irrigation pipe through the levee, 5.2 feet below the crown. Slant pump on a concrete pump platform on the waterside (WS). Siphon breaker on the landside (LS) slope. Sparling flow meter on the pipe on the WS slope. 42-inch concrete standpipe in a concrete distribution box at the landside (LS) toe. (Permit No. 1641, 1952 - William Erdman Jr.). [Additional Reference(s): DWR Levee Log, 2006. USACE Sacramento O&M Manual 130, May 1960 (HLM 9.31)]. FS Date: 9/23/2016

Pipe open where watermeter was removed.

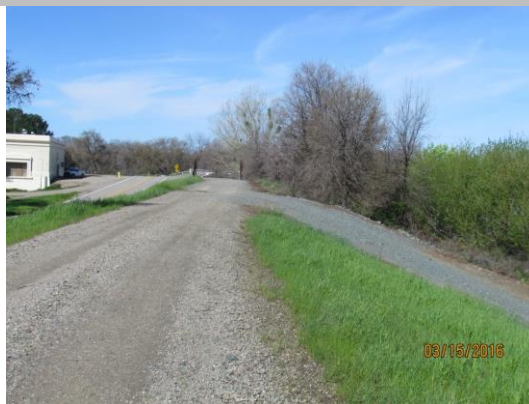
Photo 1 of 2 : SP\_2019\_NA0016\_435\_29\_20190304\_00007.jpg

View of the revegetation site on the waterward side of the levee looking upstream. Spring 2016.

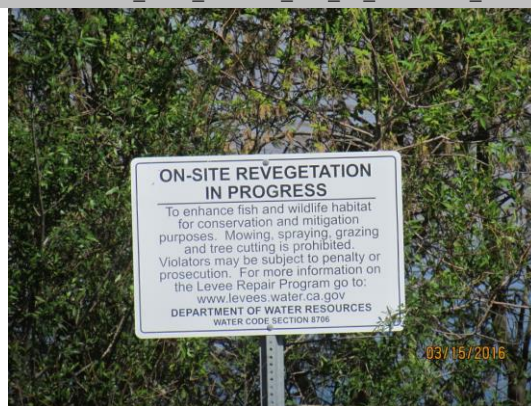
Photo 2 of 2 : SP\_2019\_NA0016\_435\_29\_20190304\_00008.jpg

Revegetation site sign. Spring 2016.

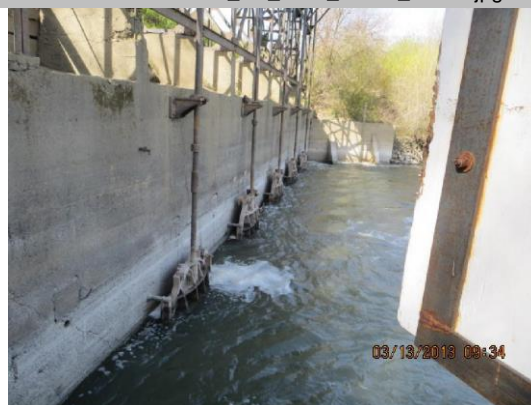
Photo 1 of 3 : UCIP\_SP\_2019\_10164\_17345.jpg

Slide gates at concrete headwall at river

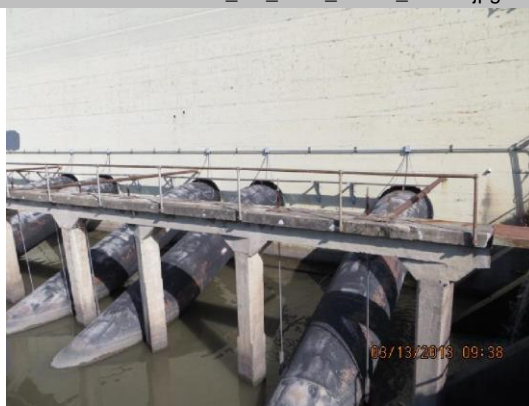
Photo 2 of 3 : UCIP\_SP\_2019\_10164\_17344.jpg

Pipes at entrance to pumping plant building on LS toe.

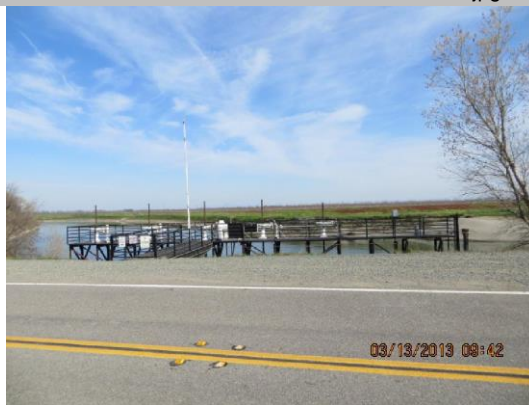
Photo 3 of 3 : UCIP\_SP\_2019\_10164\_17343.jpg

Slide gate actuators on WS shoulder.

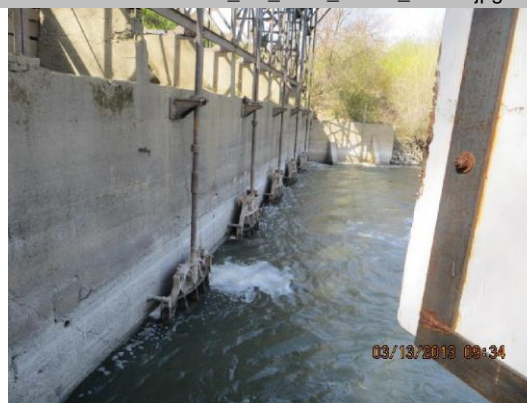
Photo 1 of 3 : UCIP\_SP\_2019\_10165\_17348.jpg

Slide gates and headwall on WS toe.

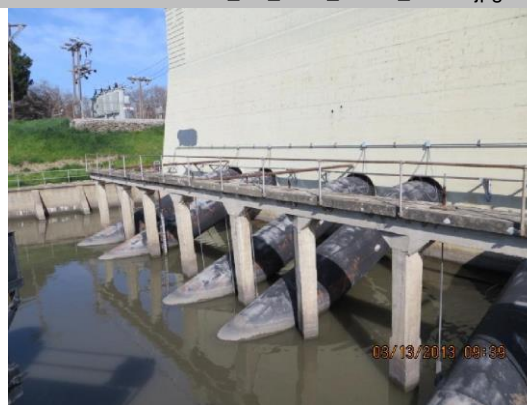
Photo 2 of 3 : UCIP\_SP\_2019\_10165\_17347.jpg

Pipes at inlet to pumphouse on LS toe.

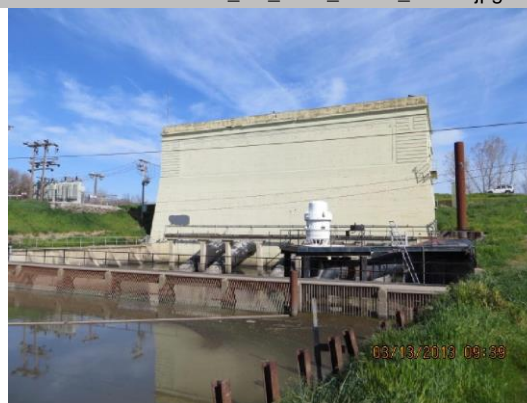
Photo 3 of 3 : UCIP\_SP\_2019\_10165\_17346.jpg

Pumphouse on LS.

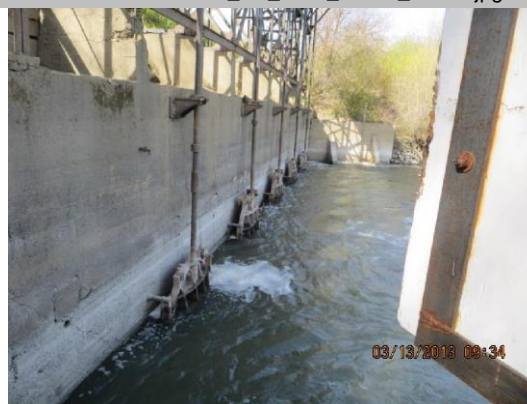
Photo 1 of 3 : UCIP\_SP\_2019\_10168\_17360.jpg

Slide gate and concrete headwall on WS toe.

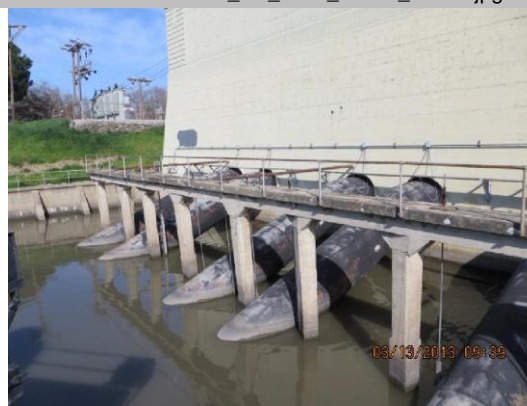
Photo 2 of 3 : UCIP\_SP\_2019\_10168\_17359.jpg

LM Start	9.76	Rating **	A/W	Issue No.	1569 (cont)
LM End	9.76	Issue Type +	Ma	Location *	
Category	Supplemental			GPS Latitude/Longitude	
				Start	End
Item	DWR UCIP LMA Responsibility			38.862633 °	38.862633 °
				-121.792669 °	-121.792669 °
DWR ID	20365				
Comment Code					
Inspector Comment					
FS_ID:10168 DS_ID:20365 EP_NO: N/A Repair Type: No Action Needed Crossing Status: Found UCIP Comments: FIELD_STRUCT_DESC: 3 of 5: 60-inch reinforced concrete drainage culvert through the levee, 35 feet below the crown. Screw gate actuators on metal platform on the waterside (WS) shoulder. Large pumping plant building on the landside (LS) shoulder. Staff gauge to 47 feet on structure. [Additional Reference(s): DWR Levee Log, 2006. USACE Sacramento O&M Manual 130, May 1960 (HLM 9.87)]. FS Date: 3/13/2013

Pipe at inlet to pumphouse on LS toe.

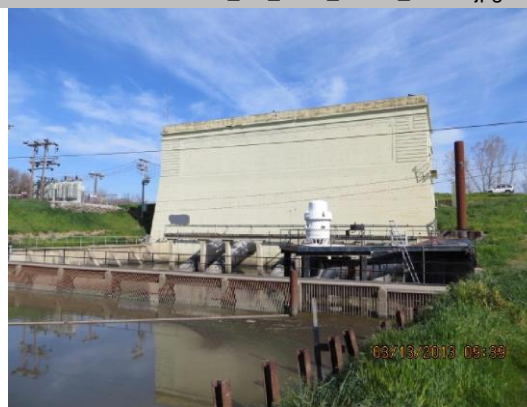
Photo 3 of 3 : UCIP\_SP\_2019\_10168\_17358.jpg

Pumphouse on LS.

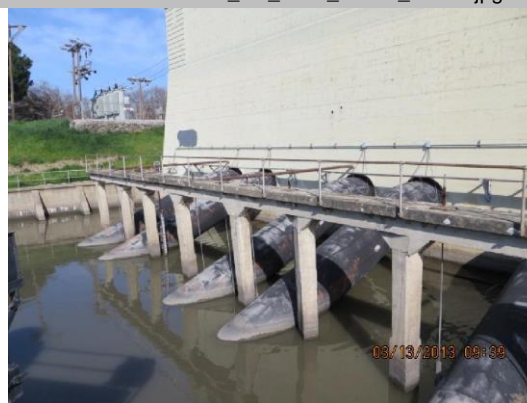
Photo 2 of 3 : UCIP\_SP\_2019\_10169\_17363.jpg

LM Start	9.76	Rating **	A/W	Issue No.	1571 (cont)
LM End	9.76	Issue Type +	Ma	Location *	
Category	Supplemental			GPS Latitude/Longitude	
				Start	End
Item	DWR UCIP LMA Responsibility			38.862650 °	38.862650 °
				-121.792754 °	-121.792754 °
DWR ID	20367				
Comment Code					
Inspector Comment					
FS_ID:10169 DS_ID:20367 EP_NO: N/A Repair Type: No Action Needed Crossing Status: Found UCIP Comments: FIELD_STRUCT_DESC: 5 of 5: 60-inch reinforced concrete drainage culvert through the levee, 35 feet below the crown. Screw gate actuators on metal platform on the waterside (WS) shoulder. Large pumping plant building on the landside (LS) shoulder. Staff gauge to 47 feet on structure. [Additional Reference(s): DWR Levee Log, 2006. USACE Sacramento O&M Manual 130, May 1960 (HLM 9.87)]. FS Date: 3/13/2013

pipes at entrance to pumphouse on LS toe.

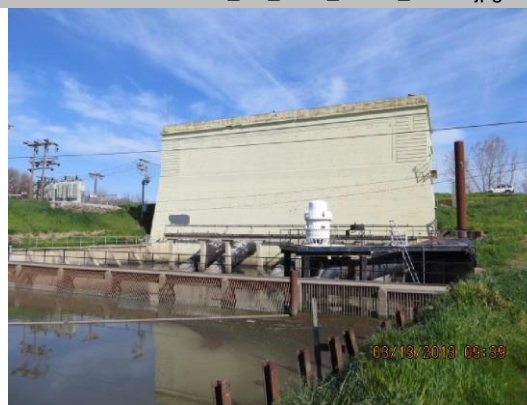
Photo 3 of 3 : UCIP\_SP\_2019\_10169\_17362.jpg

Pumphouse on LS.

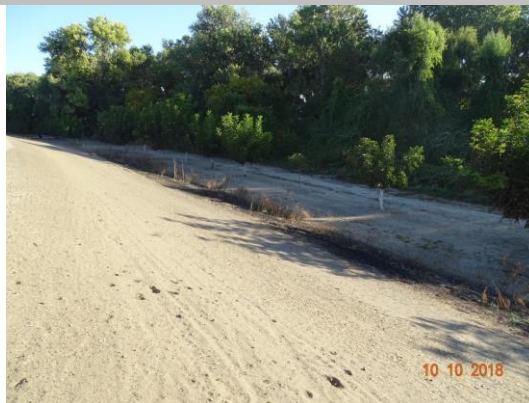
Photo 1 of 1 : SP\_2019\_NA0016\_435\_106\_20190304\_00037.jpg

LM Start	10.66	Rating **	M	Issue No.	106
LM End	10.80	Issue Type +	En	Location *	WS
Category	Earthen Levee			GPS Latitude/Longitude	
				Start	End
Item	Encroachments			38.866474 °	38.868426 °
				-121.803711 °	-121.803732 °
DWR ID	DWR_NA0016_01_f_2018_106				
Comment Code					
CR : Crops					
Inspector Comment					
A walnut orchard is located on the waterside berm.

View of walnut orchard on the waterside berm. Fall 2018.

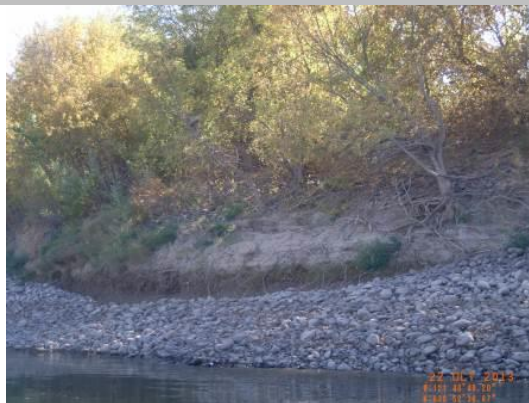
Photo 1 of 1 : SP\_2019\_NA0016\_435\_84\_20190304\_00019.jpg

LM Start	11.50	Rating **	A/W	Issue No.	84
LM End	11.53	Issue Type +	Ma	Location *	WS
Category	Supplemental			GPS Latitude/Longitude	
				Start	End
Item	2017 USACE Erosion Survey, DRAFT			38.874854 °	38.875109 °
				-121.813018 °	-121.813592 °
DWR ID	DWR_NA0016_01_f_2018_84				
Comment Code					
Inspector Comment					
2017 Site ID: SAC 101.3 R					
Status: Eroding					
2017 Field Notes: No observed change.					
Site History: 1997 - Toe damage and loss of cobble revetment and small patch of local damage to the cobble revetment. 2000 - Cohesive vertical toe: revegetation site.

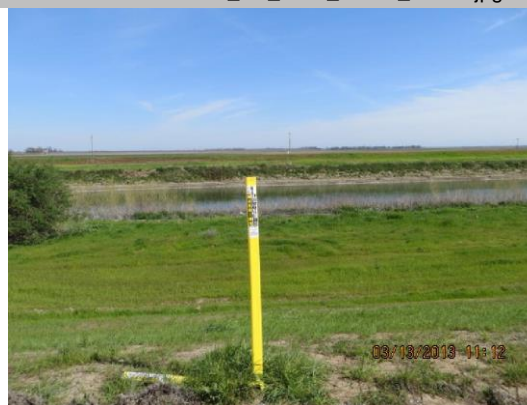
Photo 1 of 2 : UCIP\_SP\_2019\_10203\_17399.jpg

LM Start	16.22	Rating **	M	Issue No.	1572
LM End	16.22	Issue Type +	En	Location *	
Category	Supplemental			GPS Latitude/Longitude	
				Start	End
Item	DWR UCIP Field Study			38.923407 °	38.923407 °
				-121.834588 °	-121.834588 °
DWR ID	20432				
Comment Code					
Inspector Comment					
FS_ID:10203 DS_ID:20432 EP_NO: N/A Repair Type: Non-Urgent Crossing Status: Found UCIP Comments: Need to determine if this is a permitted crossing as it was not previously noted. Need to determine size and depth below the crown. FIELD_STRUCT_DESC: Gas line of an unknown material and diameter through the levee, at an unknown depth. Marker on waterside (WS) shoulder. FS Date: 3/13/2013

Gasline marker on WS shoulder.

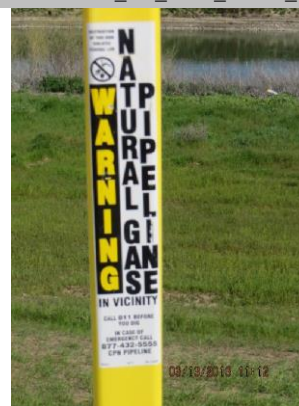
Photo 2 of 2 : UCIP\_SP\_2019\_10203\_17398.jpg

Gasline marker on WS shoulder.

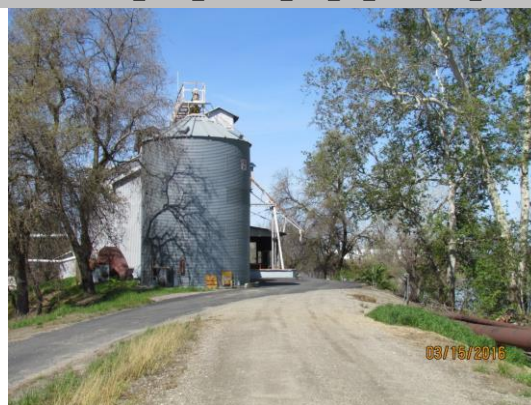
Photo 1 of 1 : SP\_2019\_NA0016\_435\_16\_20190304\_00004.jpg

LM Start	18.54	Rating **	M	Issue No.	16
LM End	18.54	Issue Type +	En	Location *	CR
Category	Earthen Levee			GPS Latitude/Longitude	
				Start	End
Item	Encroachments			38.951400 °	38.951400 °
				-121.838255 °	-121.838255 °
DWR ID	DWR_NA0016_01_f_2018_16				
Comment Code					
BU : Building					
Inspector Comment

View of the rice mill on the crown of the levee looking upstream. Spring 2016.

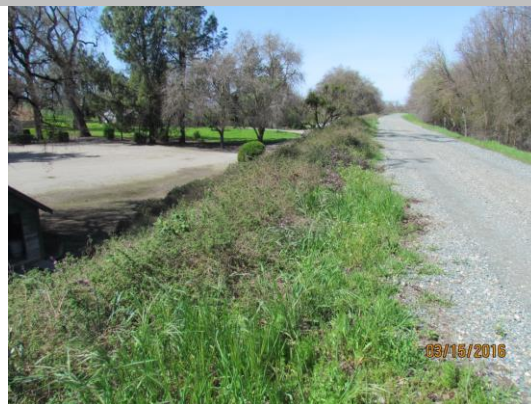
Photo 1 of 2 : SP\_2019\_NA0016\_435\_173\_20190304\_00059.jpg

LM Start	18.66	Rating **	M	Issue No.	173
LM End	18.70	Issue Type +	En	Location *	LS
Category	Earthen Levee			GPS Latitude/Longitude	
				Start	End
Item	Vegetation			38.952765 °	38.953219 °
				-121.839661 °	-121.840199 °
DWR ID	DWR_NA0016_01_s_2019_173				
Comment Code					
V6 : Landscaping					
Inspector Comment					
Permit number 16487. Owner needs to maintain/trim vegetation.

View of the landscaping on the landward side of the levee looking upstream. Spring 2016.

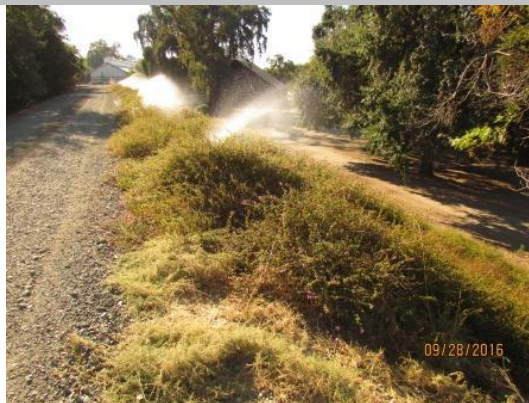
Photo 2 of 2 : SP\_2019\_NA0016\_435\_173\_20190304\_00060.jpg

Irrigated landscaping on landside slope of the levee reaching levee crown. Fall 2016 inspection.

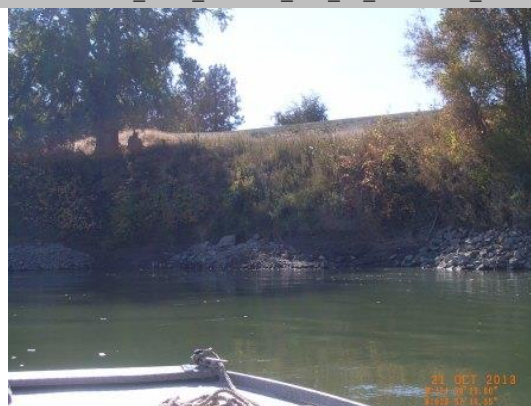
Photo 1 of 1 : SP\_2019\_NA0016\_435\_85\_20190304\_00020.jpg

LM Start	18.76	Rating **	A/W	Issue No.	85
LM End	18.78	Issue Type +	Ma	Location *	WS
Category	Supplemental			GPS Latitude/Longitude	
				Start	End
Item	2017 USACE Erosion Survey, DRAFT			38.954060 °	38.954312 °
				-121.840560 °	-121.840774 °
DWR ID	DWR_NA0016_01_f_2018_85				
Comment Code					
Inspector Comment					
2017 Site ID: SAC 111.0 R					
Status: Eroding					
2017 Field Notes: No observed change.					
Site History: 2009 - Minor erosion, should be repaired under maintenance. 2011 - Some new minor erosion at the toe.

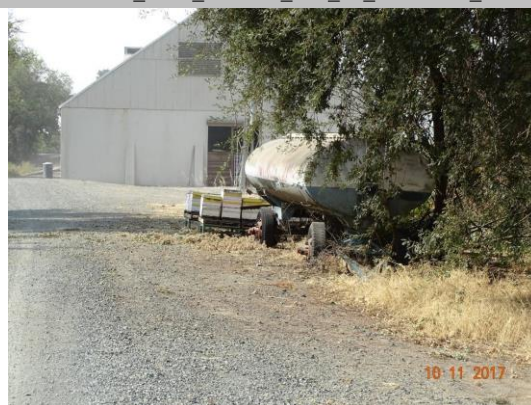
Photo 1 of 2 : SP\_2019\_NA0016\_435\_26\_20190304\_00005.jpg

LM Start	19.12	Rating **	M	Issue No.	26
LM End	19.12	Issue Type +	En	Location *	LS
Category	Earthen Levee			GPS Latitude/Longitude	
				Start	End
Item	Encroachments			38.957180 °	38.957180 °
				-121.837442 °	-121.837442 °
DWR ID	DWR_NA0016_01_s_2012_26				
Comment Code					
EQ : Equipment					
Inspector Comment					
Beehives and tank are located on the landside slope.

Updated view of equipment and beehives. Fall 2017.

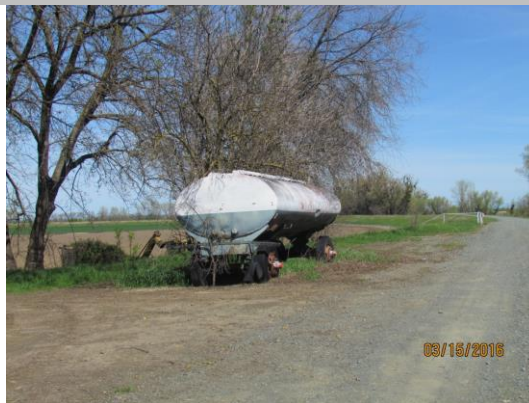
Photo 2 of 2 : SP\_2019\_NA0016\_435\_26\_20190304\_00006.jpg

View of the equipment on the crown of the levee looking upstream. Spring 2016.

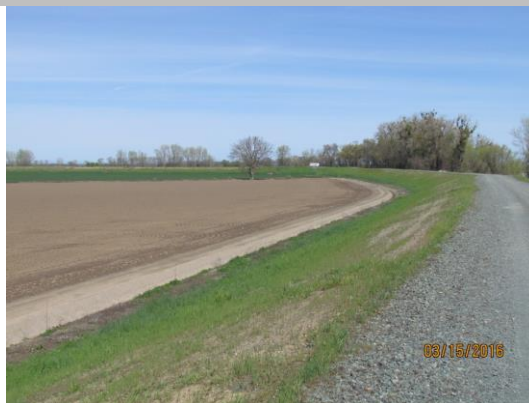
Photo 1 of 2 : SP\_2019\_NA0016\_435\_31\_20190304\_00011.jpg

LM Start	19.15	Rating **	M	Issue No.	31
LM End	19.61	Issue Type +	En	Location *	LS
Category	Earthen Levee			GPS Latitude/Longitude	
				Start	End
Item	Encroachments			38.957405 °	38.962648 °
				-121.836965 °	-121.834368 °
DWR ID	DWR_NA0016_01_s_2012_31				
Comment Code					
DT : Ditch					
Inspector Comment					
Concrete lined ditch up to LM 19.40. Soil ditch continues on until LM 19.61.

View of the ditch on the landward side of the levee looking upstream. Spring 2016.

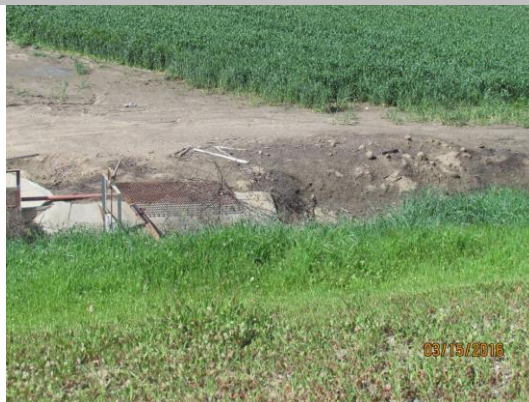
Photo 2 of 2 : SP\_2019\_NA0016\_435\_31\_20190304\_00012.jpg

Concrete lined ditch stops at levee mile 19.40.

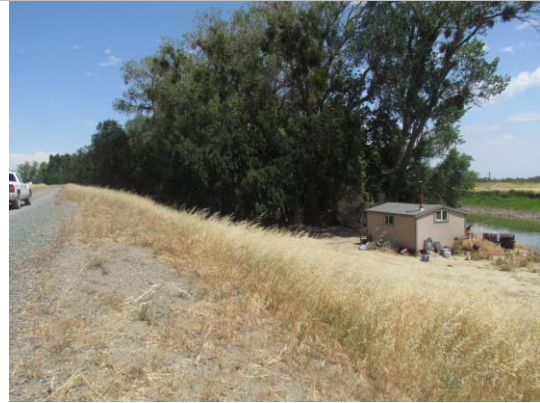
Photo 1 of 1 : SP\_2019\_NA0016\_435\_96\_20190304\_00031.jpg

LM Start	19.37	Rating **	M	Issue No.	96
LM End	19.37	Issue Type +	En	Location *	WS
Category	Earthen Levee			GPS Latitude/Longitude	
				Start	End
Item	Encroachments			38.959642 °	38.959642 °
				-121.834004 °	-121.834004 °
DWR ID	DWR_NA0016_01_s_2015_96				
Comment Code					
BU : Building					
Inspector Comment

View of the building on the waterward side of the levee looking upstream. Spring 2015.

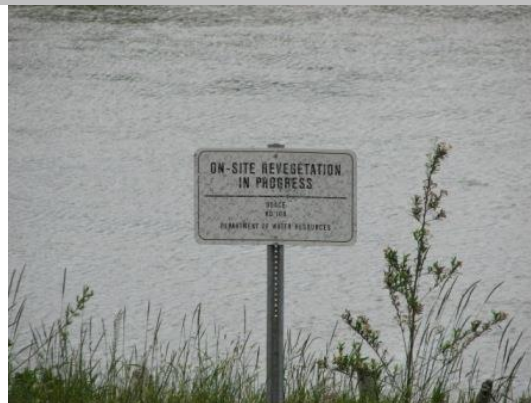
Photo 1 of 2 : SP\_2019\_NA0016\_435\_30\_20190304\_00009.jpg

LM Start	22.12	Rating **	A/W	Issue No.	30
LM End	22.42	Issue Type +	Ob	Location *	WS
Category	Earthen Levee			GPS Latitude/Longitude	
				Start	End
Item	Vegetation			38.989528 °	38.989722 °
				-121.816020 °	-121.810488 °
DWR ID	DWR_NA0016_01_f_2018_30				
Comment Code					
V8 : Environmental Requirements.					
Inspector Comment

Revegetation site. Photo taken spring 2012.

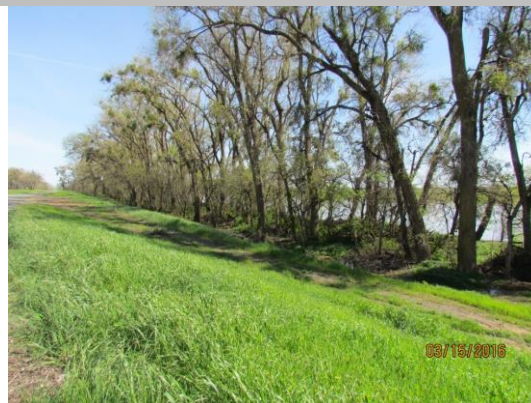
Photo 2 of 2 : SP\_2019\_NA0016\_435\_30\_20190304\_00010.jpg

View of the revegetation on the waterward berm of the levee looking upstream. Spring 2016.
